# **Intel<sup>®</sup> Pentium<sup>®</sup> III Xeon<sup>™</sup> Processor Specification Update**

Release Date: June 2002

Order Number: 244460-036

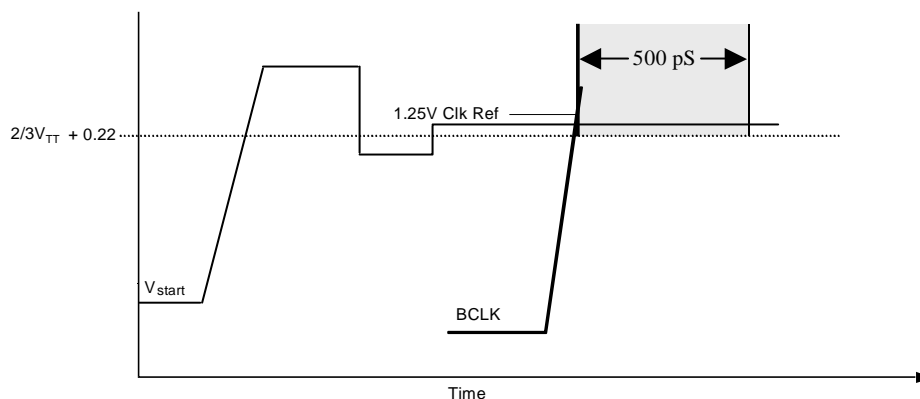
The published AGTL+ AC specification for  $V_{IH(MIN)}$  is  $(2/3 \cdot V_{TT}) + 0.1$  Volts.

Intel has characterized the new AGTL+ AC specification for  $V_{IH(MIN)}$  on the processor's RS0# signal to be:  $(2/3 \cdot V_{TT}) + 0.22$  Volts within 500 picoseconds following the rising edge of BCLK crossing the 1.25-Volt threshold. See below.

**Implication:** The deviation from the published specification results in decreased noise margin on the RS0# processor input. This decreased noise margin has been observed to be particularly detrimental in system environments where the RS0# processor input is being driven by an I/O buffer with a pull-up device (such as a p-channel transistor) that is switched off mid-cycle. Systems that employ I/O buffers that keep the pull-up device on for the entire cycle are significantly less affected by this erratum. The reduction in noise margin may lead to the generation of BINIT# (when enabled) resulting in a system reset, otherwise this condition may lead to a system "hang" condition.

**Workaround:** If a system design cannot meet the specification deviation, the following areas should be carefully examined to assure that additional margin exists in order to compensate for any deficit observed with respect to the newly characterized  $V_{IH(MIN)}$  specification:

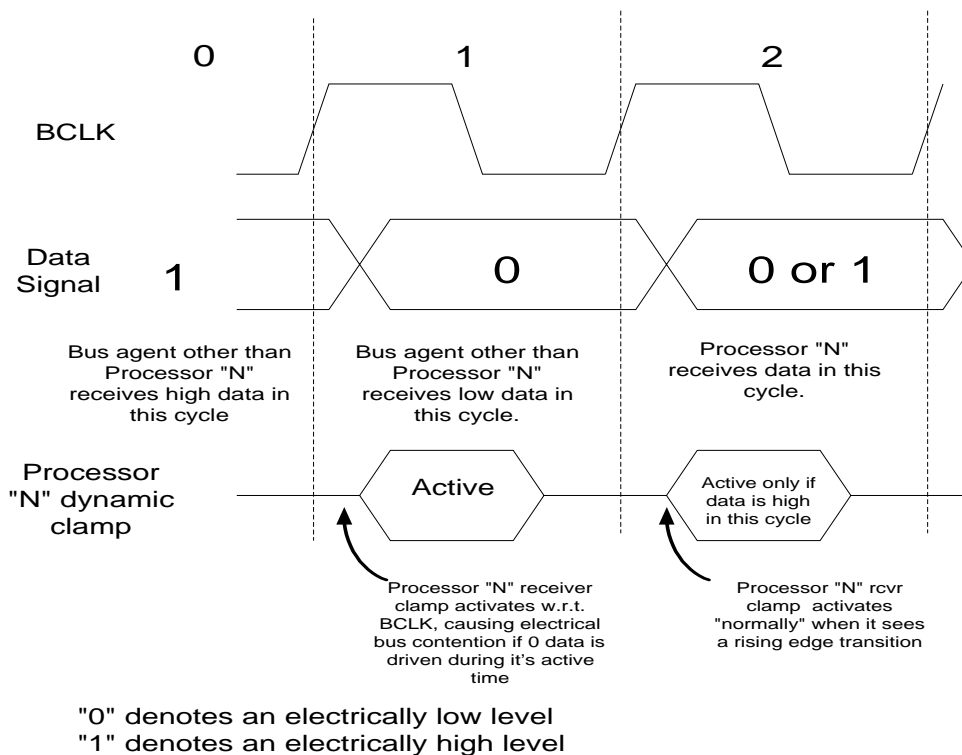
**Problem:** Falling edge ledge push-out and undershoot may be seen on AGTL+ data and data bus ECC signals. The AGTL+ receiver's dynamic clamp circuit activates (i.e. clamps the signal to an electrically high level) in certain cycles when data is driven to an electrically low level by another agent.

**Implication:** This erratum only occurs on a processor that does not receive data in that particular cycle. More specifically, this erratum only occurs when a specific processor does not receive data in the current BCLK period, but receives data in the very next period. Therefore, the processor inducing this falling edge noise (on data and data bus ECC signals) will not actually read the data in that cycle. See below for an illustration of this erratum affecting a processor denoted Processor "N". The falling edge ledges and undershoots may affect the signal quality and/or timing at agents that receive data in that cycle. Therefore, the impact of this erratum is highly dependent on system bus design.

**Workaround:** Evaluate system bus signal quality and timing margin at the valid receiving agent as a result of this falling edge noise. Due to dependence upon system bus design, bus layout may be evaluated to determine the need for improvements in signal quality and timing margin at the valid receiving agent as a result of this receiver-induced falling edge noise.
